# Geohistory and geomorphology of the Mitlatongo landslide, Oaxaca, Mexico

**Abstract** When a landslide occurs, the landscape is radically transformed; a pristine, unexplored geography emerges, with new morphogenetic processes. When the event also affects human settlements, it is crucial to understand all the physical and geographic factors that explain it and all its multiple social implications. In September 2011, a landslide occurred in the Mitlatongo Valley, rendering more than 400

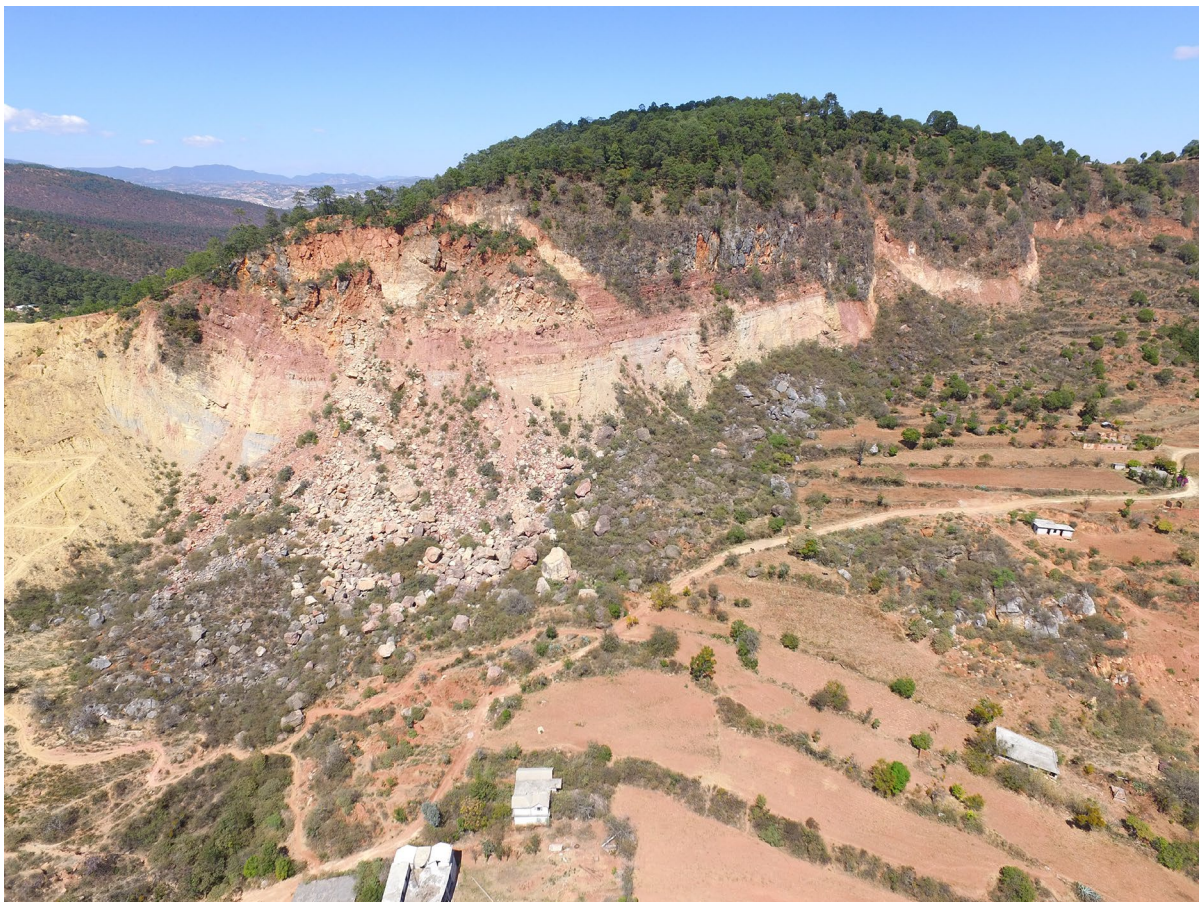
According to local accounts, the phenomenon began to manifest slowly during the first days of September 2011. The persistent rains saturated the soil, particularly on the northern flank known as Peña Colorada (see Fig. 1). This saturation led to rockslides in the rupture zone. It facilitated the displacement of the terrain toward the south, where the two towns of Santiago Mitlatongo and Santa Cruz

**Fig. 1** Rupture zone located on the northern flank beneath Peña Colorada hill, February 2021

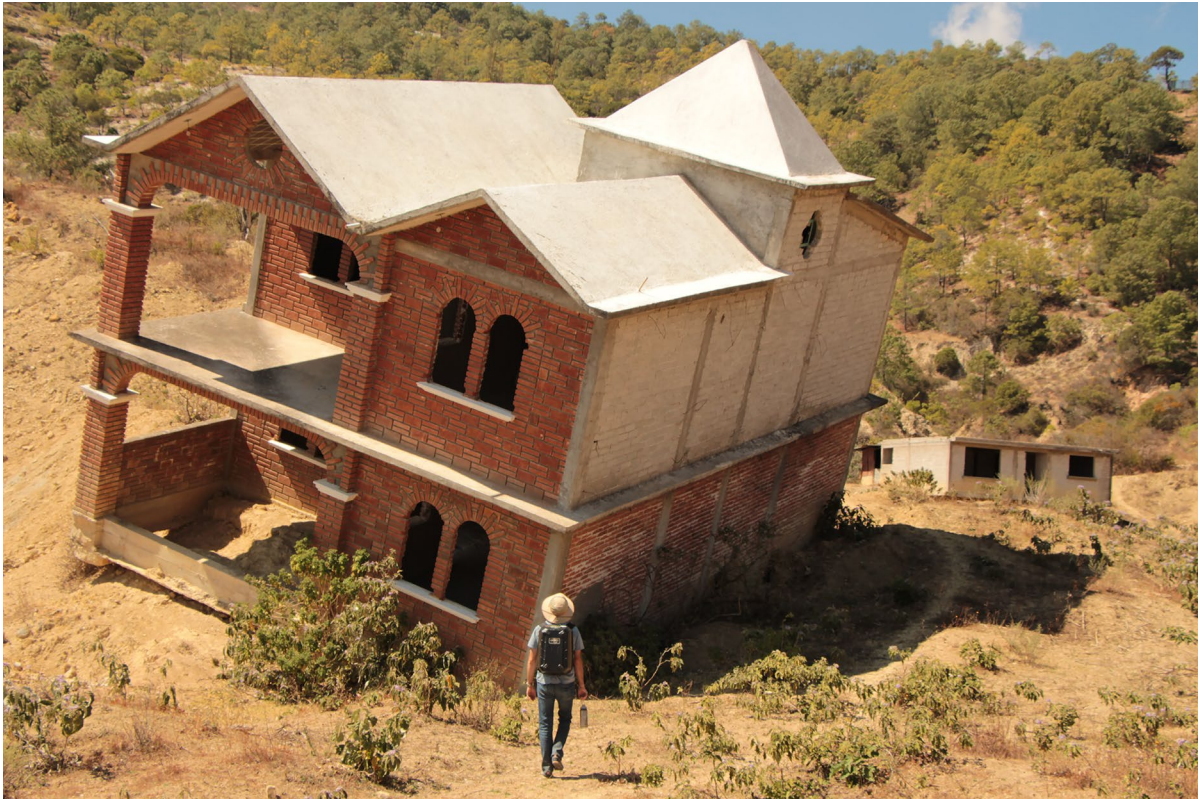
displacement: in the upper part of the rotational landslide, the displacement was 60 meters, while in the central sector, it reached 225 meters (Figs 5 and 6).

**Fig. 6** An image of one of the houses displaced more than 200 meters from where it was originally built. February 2021

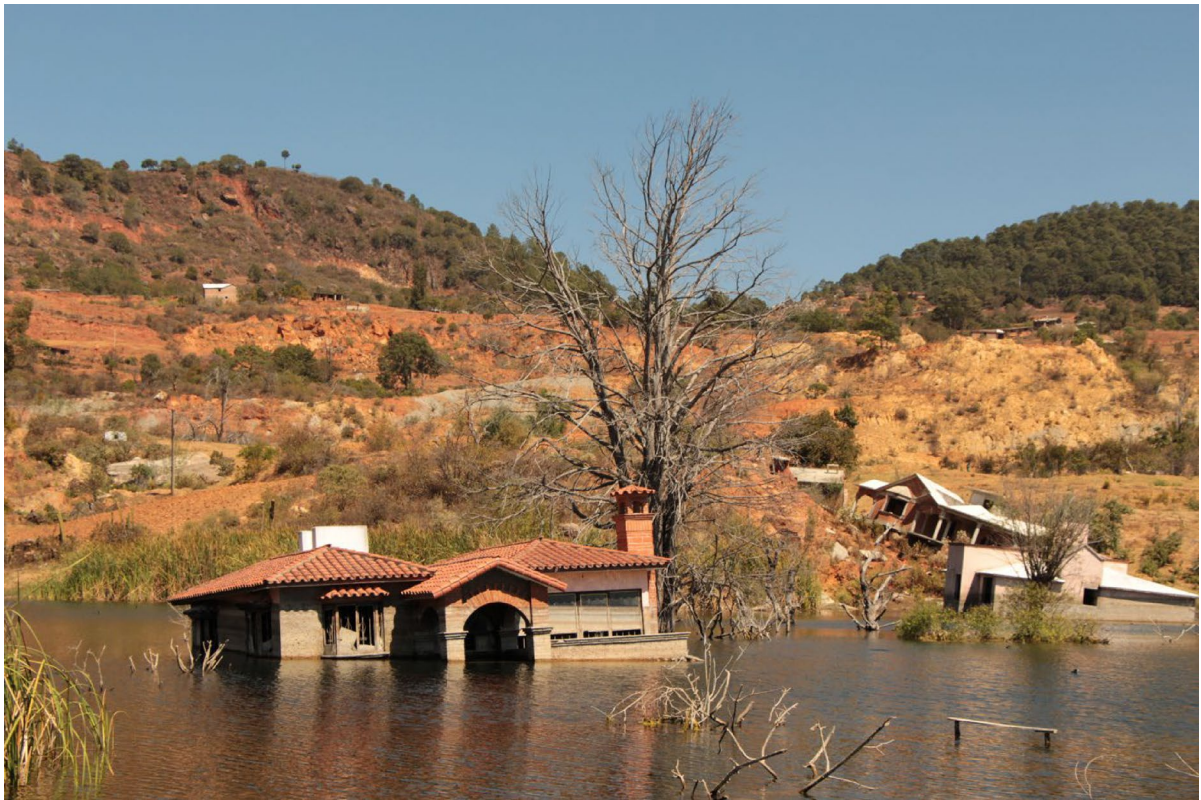
The geomorphological analysis indicates that the dynamics of the mass movement were influenced by pre-existing conditions and triggering factors. The presence of a fracture in the head zone since 1995 suggests that the valley has been undergoing instability processes for decades. Differences in the morphology and displacement of the units indicate that sliding did not occur homogeneously. In the eastern section, the material moved as a translational flow, while in the western section, the rotational movement originated a stepped topography with terraces and subsidence. The transformation of the relief resulted in the appearance of new bodies of water and the alteration of the water network prior to the event (Fig. 8).

**Fig. 8** Water body developed after the 2011 landslide. February 2021
